**Flood Control Project Maintenance  
Levee Inspections**

## Maintenance Issue Types Only, Levee Inspection Report By Mile - Spring 2018

### City of Sacramento

Waterway	Bank	Unit Miles	Inspection Start/End	Inspector
Unit No. 01 Sacramento River	Left	3.67	03/20/2018 03/20/2018	Zach Jojola

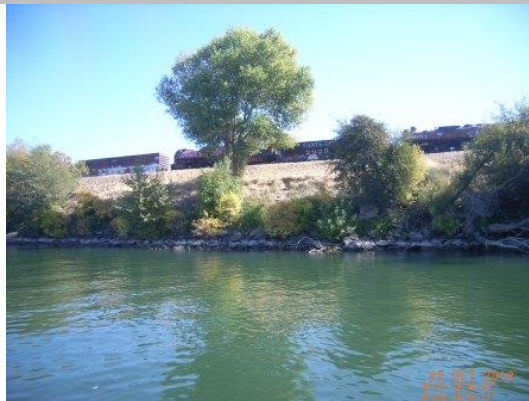
Photo 1 of 2 : SP\_2018\_NA0005\_251\_1\_20180319\_00001.jpg

LM Start	1.31	Rating **	M	Issue No.	1
LM End	1.39	Issue Type +	Ma	Location *	WS
Category	Supplemental			GPS Latitude/Longitude	
				Start	End
Item	2015 USACE Erosion Survey, DRAFT			38.573169 °	38.572277 °
				-121.511998 °	-121.513063 °
DWR ID	DWR_NA0005_01_s_2016_1				
Comment Code					
Inspector Comment					
2008 - Oversized levee, should be repaired under maintenance. 2009 - Shallow slumps at the mid bank. 2010 - Some minor erosion at the toe, likely from wave wash. Some new shallow slumps. 2011 - One new tree has fallen. 2013 - Erosion continues on the slope surface, site extended upstream. 2015: No observed changes. [2015 Site ID: SAC 58-5 L]

USACE 2013 Photo #1

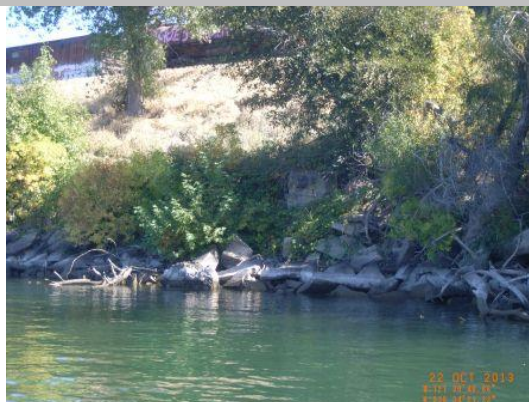
Photo 2 of 2 : SP\_2018\_NA0005\_251\_1\_20180319\_00002.jpg

USACE 2013 Photo #2

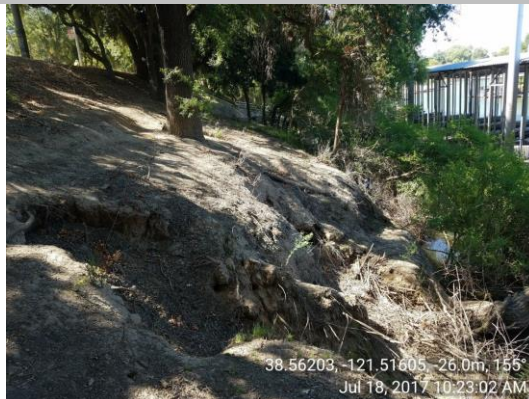
Photo 1 of 3 : LEVAL\_SP\_2018\_492\_1797.jpg

LM Start	<b>2.15</b>	Rating **	A/W	Issue No.	<b>81</b>
LM End		Issue Type +	Ma	Location *	
Category	Supplemental		GPS Latitude/Longitude		
			Start	End	
Item	2017 Storm Damage		38.562070 °	°	
			-121.515770 °	°	
DWR ID	DWR_NA0005_01_f_2017_81				
Comment Code					
Inspector Comment					
Levee Evaluation Comments					
Description:					
Site ID No:492					
Site Designation:SCDU-07					
Repair Type: Erosion					
Rating:Serious					
Field Date:7/18/2017					
Notes: Erosion length = 80 feet					
City will repair this section summer 2018.

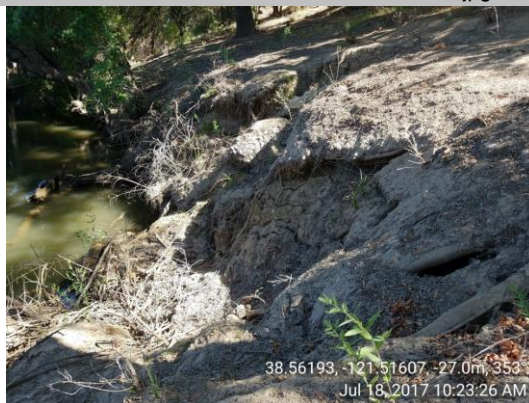
Photo 2 of 3 : LEVAL\_SP\_2018\_492\_1740.jpg

LM Start	2.15	Rating **	A/W	Issue No.	81 (cont)	
LM End		Issue Type +	Ma	Location *		
Category	Supplemental			GPS Latitude/Longitude		
				Start	End	
Item	2017 Storm Damage			38.562070 °		
				-121.515770 °		
DWR ID	DWR_NA0005_01_f_2017_81					
Comment Code						
Inspector Comment						
Levee Evaluation Comments						
Description:						
Site ID No:492						
Site Designation:SCDU-07						
Repair Type: Erosion						
Rating:Serious						
Field Date:7/18/2017						
Notes: Erosion length = 80 feet						
City will repair this section summer 2018.

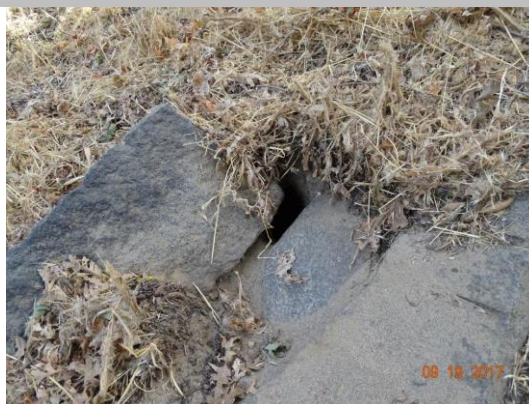
Photo 1 of 1 : SP\_2018\_NA0005\_251\_82\_20180319\_00020.jpg

LM Start	2.31	Rating **	A/W	Issue No.	82
LM End	2.31	Issue Type +	Ma	Location *	WS
Category	Earthen Levee			GPS Latitude/Longitude	
				Start	End
Item	Animal Control			38.559767 °	38.559767 °
				-121.515264 °	-121.515264 °
DWR ID	DWR_NA0005_01_s_2016_82				
Comment Code					
A3 : No rodents visible, but rodent burrows visible; need to backfill and compact or grout burrows.					
Inspector Comment					
City of Sac grouted this area and will continue to monitor.

View of rodent hole on wateside slope. Fall 2017.
